REPORT BY OFFICE OF THE BALTIMORE CITY STATE'S ATTORNEY  
ON THE FATAL MOTOR VEHICLE ACCIDENT  
AT 1901 E. NORTH AVENUE ON FEBRUARY 8, 2023

IVAN BATES, STATE'S ATTORNEY FOR BALTIMORE CITY

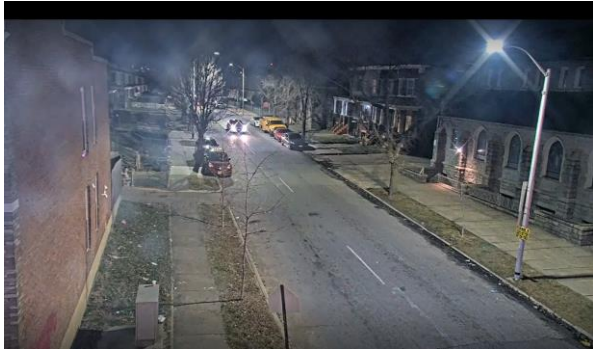
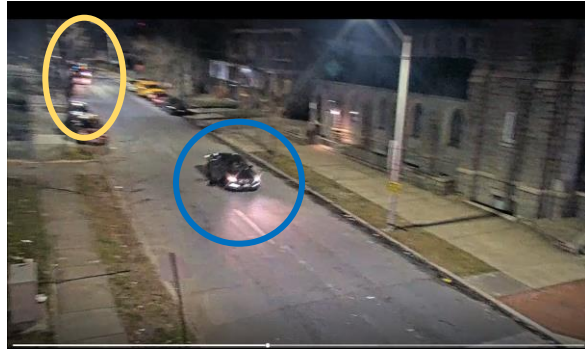
P/O Yancey's car in yellow

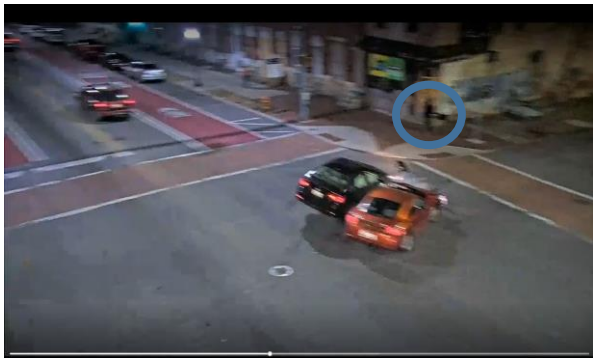
Mr. Brunson's car in blue.
