REPORT BY OFFICE OF THE BALTIMORE CITY STATE'S
ATTORNEY ON THE CITIZEN VEHICULAR FATALITY
LOCATED AT 300 HILTON PARKWAY

MARILYN MOSBY, STATE'S ATTORNEY FOR BALTIMORE
CITY

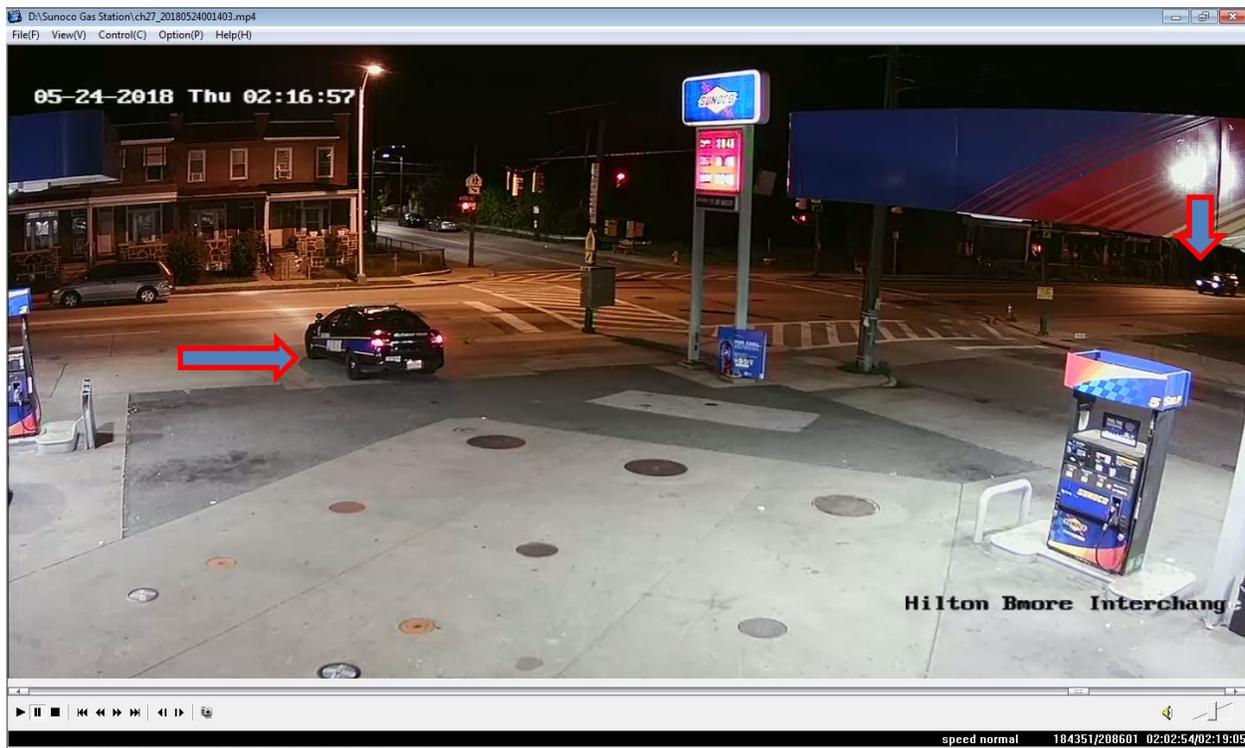
This is the view from the Sunoco gas station's camera. It shows the IO in a tactical position for traffic enforcement. On the far right, this is the first time that there is a video of the Involved Citizens.

2. Business video captured at Sunoco. This video is crystal clear. The officer is seen putting his cruiser in a tactical position for traffic enforcement. The Tahoe drives by, and it is clear that the officer had an unobstructed view of the Tahoe; however, the headlights are clearly on. The front license plate cannot be seen. Given the angle of the video, a license plate could potentially have been properly attached and not picked up by the video. That being said, there are other cars that pass by. However, because of the reflections from both moving and stationary lighting sources, you can see those other cars' license plates. This gives rise to the inference that if the Tahoe in fact had a properly mounted plate, you would be able to see it from the Sunoco camera.

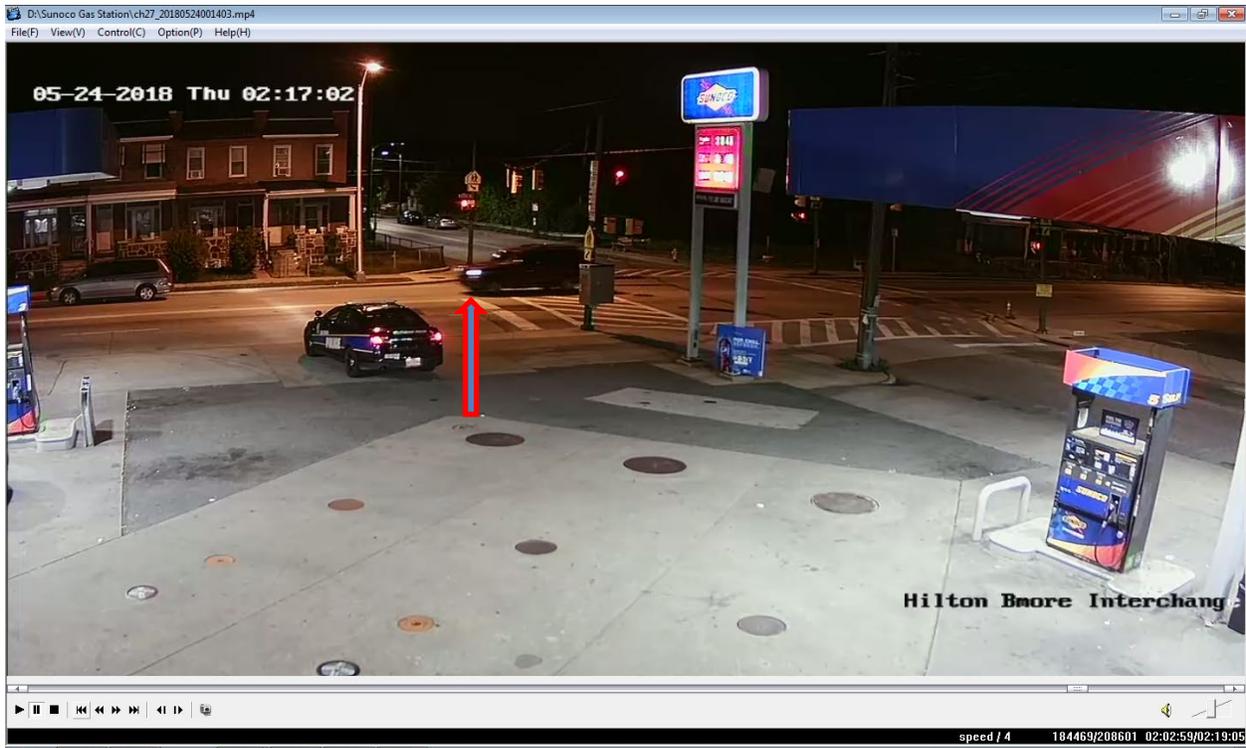
The Involved Citizens and the Tahoe are passing the Involved Officer. In the time frame between this picture and the last picture, there is no indicia of the front license plate being affixed.

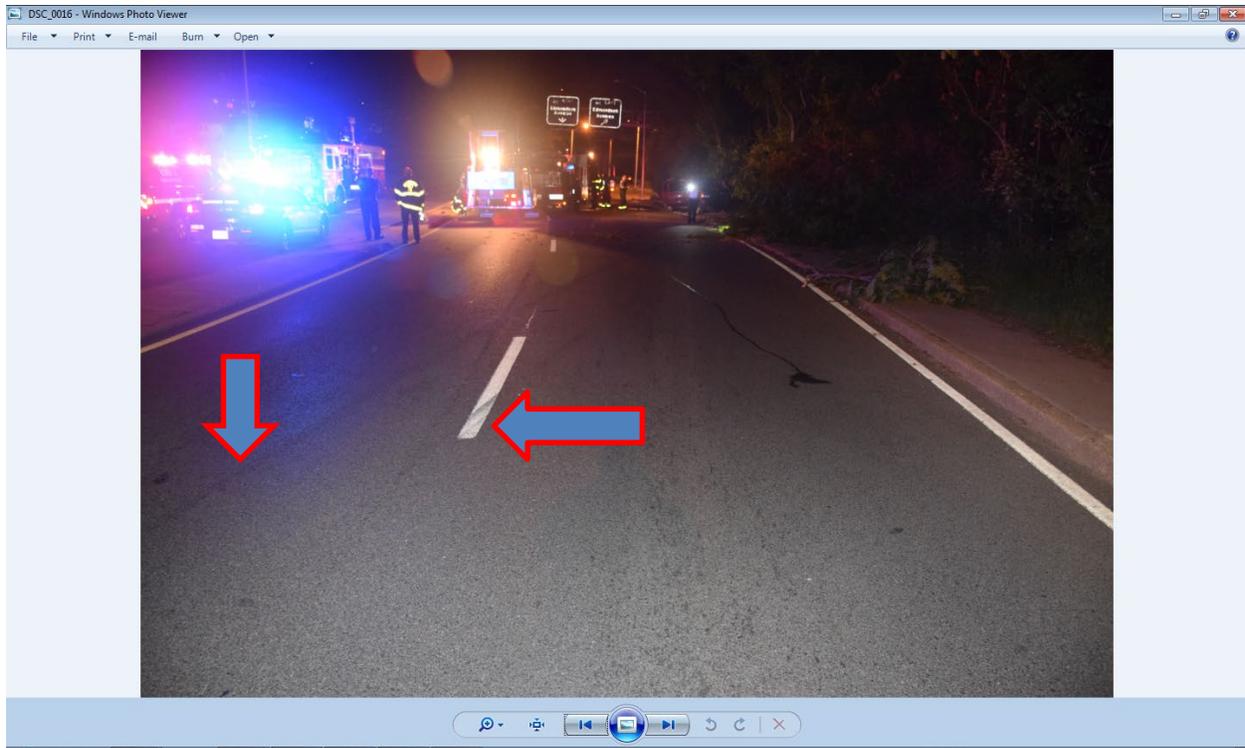
AUI's picture of the pavement where they believe the Tahoe began to lose control (in lane #1, "the fast lane"). The trajectory of the tread marks lead directly to where the tree was down in the road way (the tree was removed prior to this picture being taken).

AIU determined the following: 1) that the vehicle was travelling at 70 mph just 2 seconds prior to the crash; 2) that the driver was accelerating and gaining speed in the 6 seconds prior to the crash (except for the last second prior to the crash); 3) that the brakes were not applied in the 5 seconds prior to the crash; and, 4) that the speed at impact with the tree(s) was 57.99 mph. The speed limit on that part of the road was 25 mph.

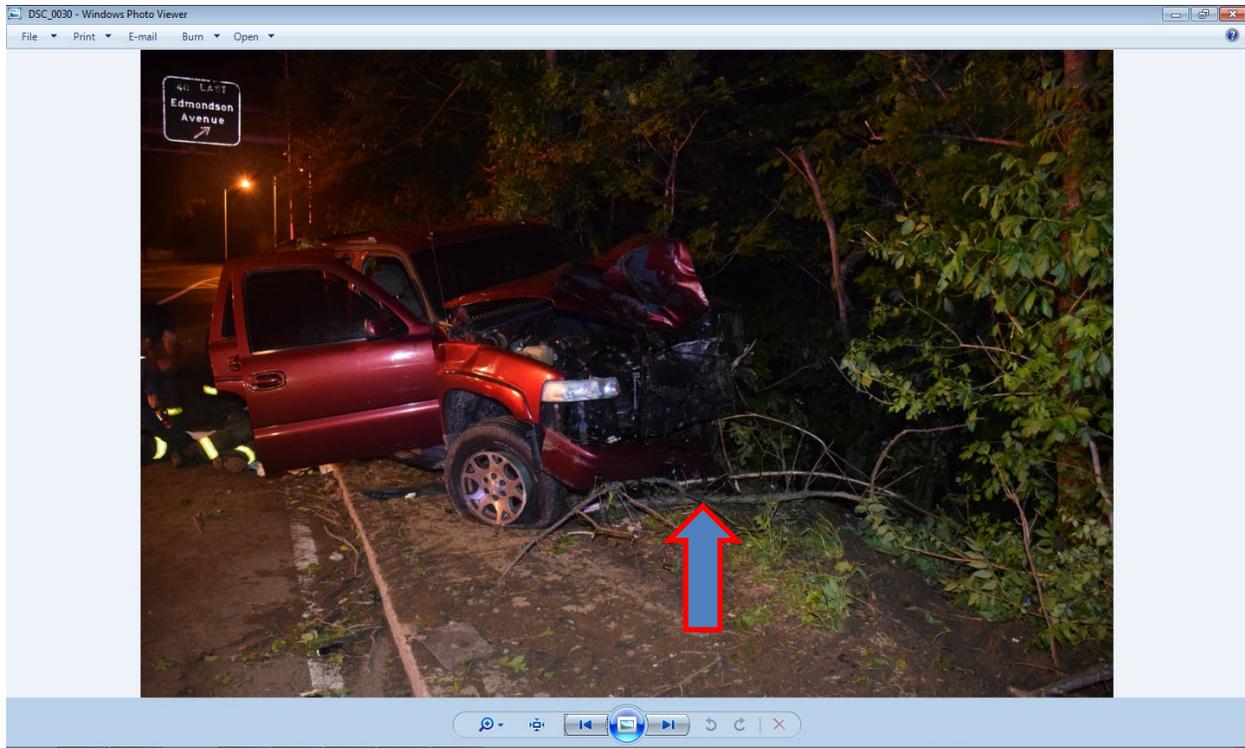
AIU took several pictures of the scene. This shows the front of the Tahoe after it had been flipped from its side and onto its tires. There is no front license plate attached. The investigators did find the license plate, but indicated that there's no evidence of it having been attached and "separated" during the accident (not bent, not scuffed, no grass/tree stains), strongly suggesting that the plate had been removed prior to the accident and was located in the interior of the Tahoe at the moment that it passed the Involved Officer at the Sunoco station.
